**Flood Control Project Maintenance
Levee Inspections**

Maintenance Issue Types Only, Levee Inspection Report By Mile - Spring 2018

Butte County Department of Public Works

Waterway	Bank	Unit Miles	Inspection Start/End	Inspector
Unit No. 01 Mud Creek	Right	6.80	03/20/2018 03/20/2018	Bob Duffey

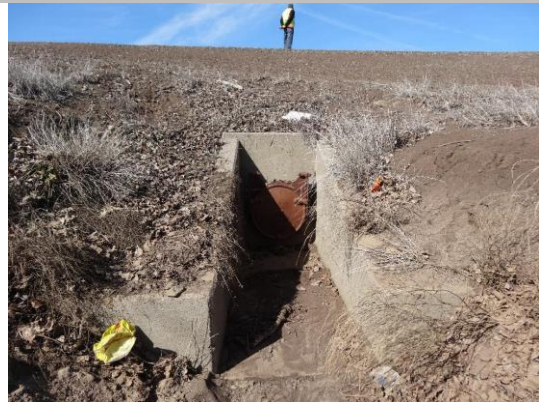
Photo 1 of 3 : UCIP_SP_2018_29705_54924.jpg

WS view: U typed concrete headwall, flapgate on levee slope.

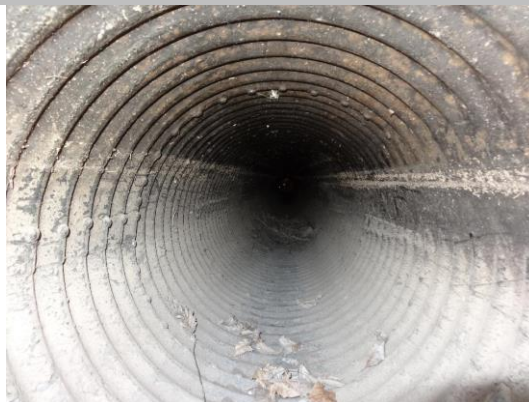
Photo 3 of 3 : UCIP_SP_2018_29705_54922.jpg

LS view: inside view of CMP on levee slope. Looks clean and clear.

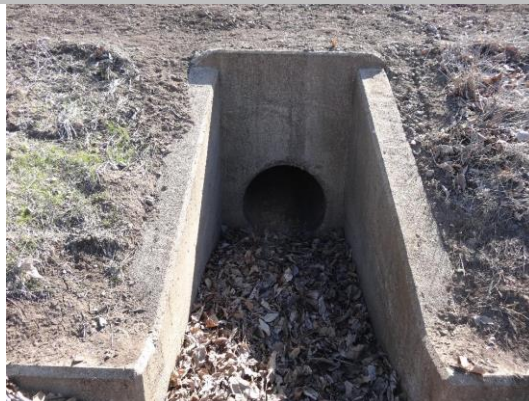
Photo 3 of 3 : UCIP_SP_2018_32044_58541.jpg

LS view: U typed concrete headwall and CMP on levee slope.

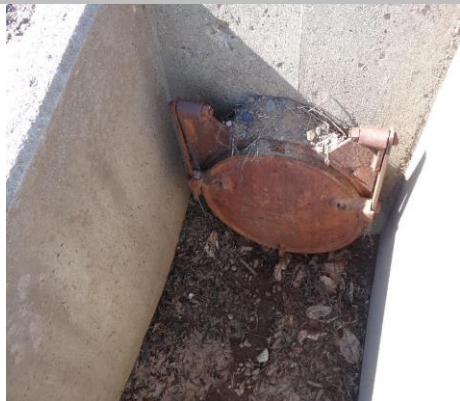
Photo 1 of 2 : UCIP_SP_2018_30294_55704.jpg

WS view: U type concrete headwall, flapgate on levee slope.

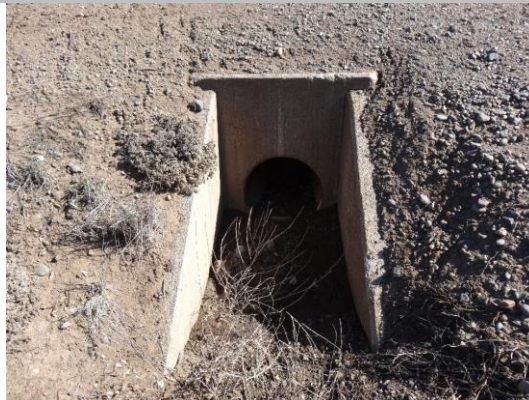
Photo 2 of 2 : UCIP_SP_2018_30294_55703.jpg

LS view: U type concrete headwall and CMP on levee slope. Debris blocking the inlet pipe.

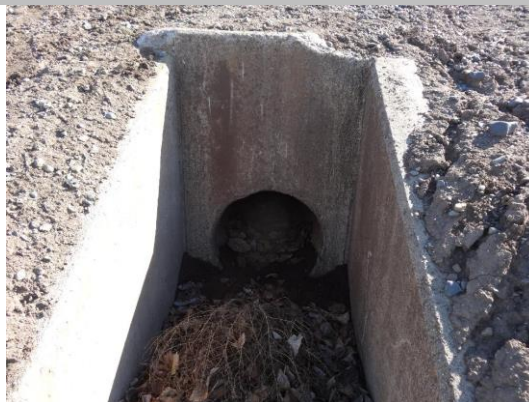
Photo 2 of 3 : UCIP_SP_2018_30310_55740.jpg

LS view: U type concrete headwall and CMP on levee slope.

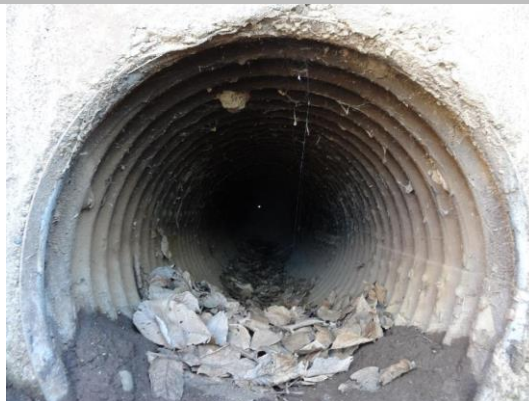
Photo 3 of 3 : UCIP_SP_2018_30310_55739.jpg

LS view: inside view of CMP on levee slope. Needs cleaning and clearing.

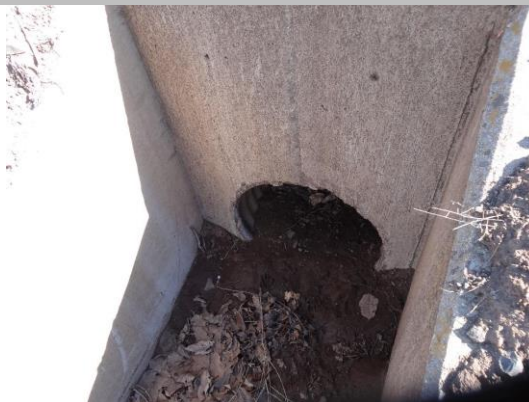
Photo 2 of 2 : UCIP_SP_2018_30311_55742.jpg

LS view: U type concrete headwall and CMP on levee slope.

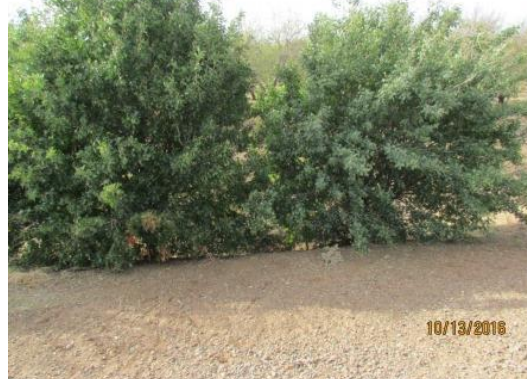
Photo 1 of 1 : SP_2018_NA0003_64_53_20180305_00032.jpg

LM Start	4.45	Rating **	M	Issue No.	53
LM End	4.45	Issue Type +	Ma	Location *	LS
Category	Earthen Levee			GPS Latitude/Longitude	
				Start	End
Item	Trim / Thin Trees			39.775789 °	39.775789 °
				-121.894048 °	-121.894048 °
DWR ID	DWR_NA0003_01_f_2016_53				
Comment Code					
T1 : Trim trees to at least five feet above ground level.					
Inspector Comment

View of the trees along the landside toe.

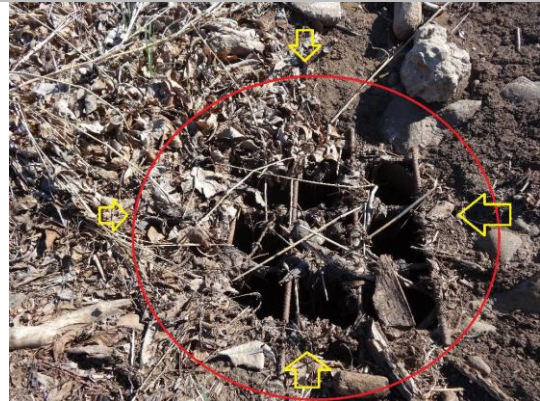
Photo 2 of 2 : UCIP_SP_2018_30388_55890.jpg

Comment Code						
Inspector Comment						
FS_ID:30388						
DS_ID:19221						
EP_NO: N/A						
Repair Type: Non-Urgent						
Crossing Status: Found						
UCIP Comments: CM Standpipe intake. Intake pipe with air vent. Steel rib-bar grit cover on the standpipe on landside levee toe.Needs cleaning and clearing on both ends of the pipe.						
FIELD_STRUCT_DESC: 24-inch corrugated metal gravity drainage pipe through the levee, 15 feet below the crown. Flap gate on the waterside (WS) end. Concrete U-shaped headwall on the WS end. Grouted riprap spillway on the WS end. Corrugated metal standpipe intake. Intake pipe with an air vent. Steel rib-bar grit cover on the standpipe on the landside (LS) toe. [Additional Reference(s): DWR Levee Log, 1992. USACE Sacramento O&M Manual 504, May 1965, (HLM 4.94)].						
FS Date: 2/20/2014

LS view: Underground CM standpipe intake with steel grit on levee toe.

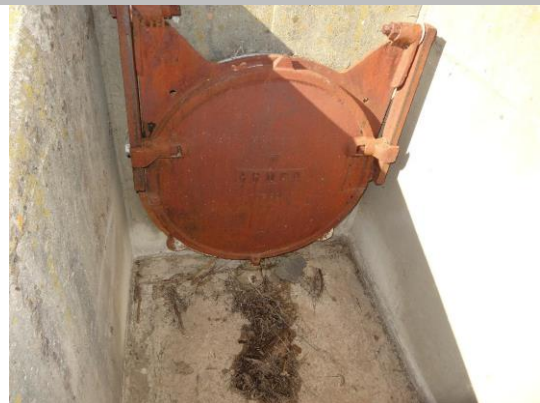
Photo 1 of 3 : UCIP_SP_2018_30327_55768.jpg

WS view: U type concrete headwall, pipe, and flapgate on levee slope.

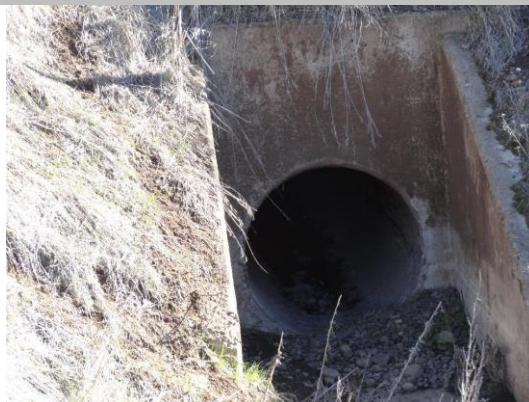
Photo 3 of 3 : UCIP_SP_2018_30327_55766.jpg

LS view: U type concrete headwall and CMP on levee slope.

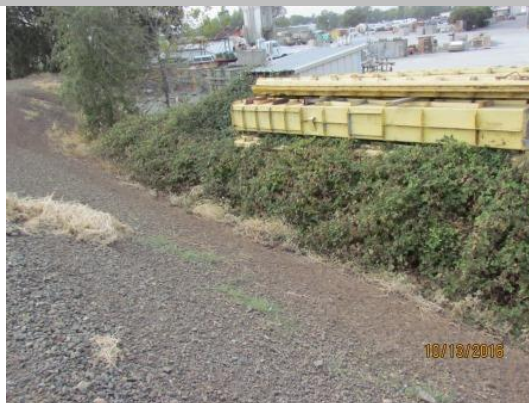
Photo 1 of 1 : SP_2018_NA0003_64_55_20180305_00033.jpg

LM Start	5.20	Rating **	M	Issue No.	55
LM End	5.20	Issue Type +	Ma	Location *	LS
Category	Earthen Levee			GPS Latitude/Longitude	
				Start	End
Item	Vegetation			39.784234 °	39.784234 °
				-121.886589 °	-121.886589 °
DWR ID	DWR_NA0003_01_f_2016_55				
Comment Code					
V2 : Remove the wild growth other than native grasses from the levee slopes.					
Inspector Comment

View of the blackberries blocking visibility and access.

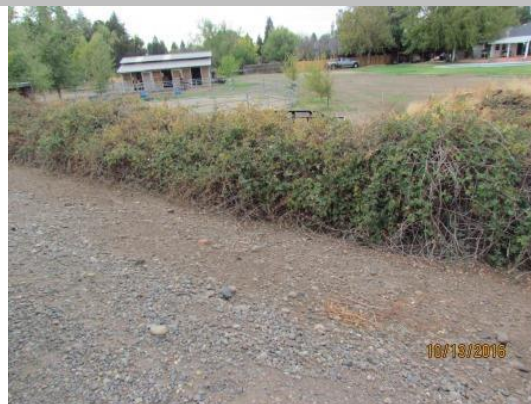
Photo 1 of 1 : SP_2018_NA0003_64_22_20180305_00005.jpg

LM Start	5.96	Rating **	M	Issue No.	22
LM End	5.96	Issue Type +	Ma	Location *	LS
Category	Earthen Levee			GPS Latitude/Longitude	
				Start	End
Item	Vegetation			39.793116 °	39.793116 °
				-121.887296 °	-121.887296 °
DWR ID	DWR_NA0003_01_f_2016_22				
Comment Code					
V4 : Elderberries are blocking visibility and flood fight capability.					
Inspector Comment					
Blackberry bramble

View of the blackberries blocking visibility and access.

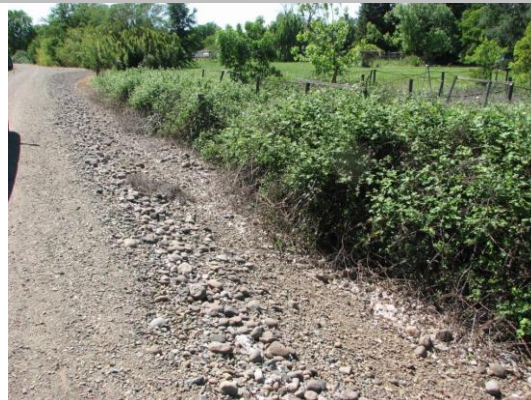
Photo 1 of 1 : SP_2018_NA0003_64_34_20180305_00016.jpg

LM Start	6.16	Rating **	M	Issue No.	34
LM End	6.16	Issue Type +	Ma	Location *	LS
Category	Earthen Levee			GPS Latitude/Longitude	
				Start	End
Item	Vegetation			39.795428 °	39.795428 °
				-121.885306 °	-121.885306 °
DWR ID	DWR_NA0003_01_s _ 2016_34				
Comment Code					
V2 : Remove the wild growth other than native grasses from the levee slopes.					
Inspector Comment					
Blackberry bramble on landside toe blocking visibility.

Trim vegetation at L/S toe.

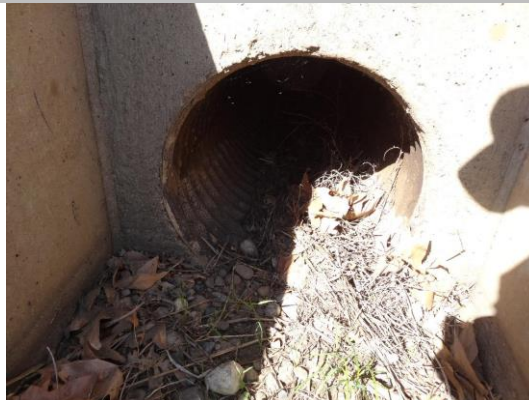
Photo 2 of 3 : UCIP_SP_2018_30403_55921.jpg

LS view: U type concrete headwall and CMP on levee slope. Vegetation debris in inlet pipe.

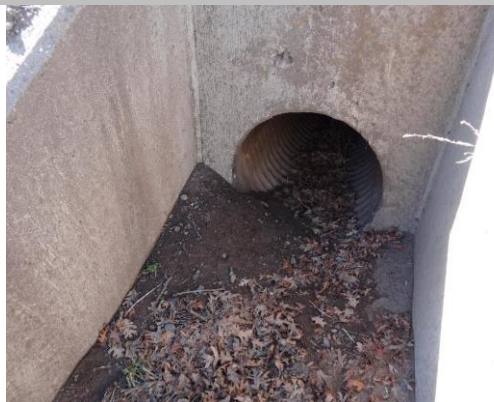
Photo 2 of 3 : UCIP_SP_2018_30783_56681.jpg

LS view: U type concrete headwall and CMP on levee slope. Debris and soil in inlet box.

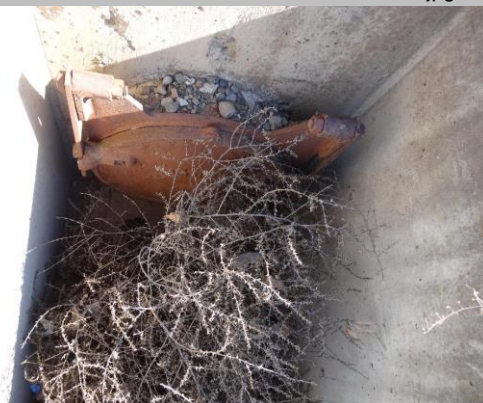
Photo 1 of 3 : UCIP_SP_2018_30803_56685.jpg

LM Start	3.50	Rating **	M	Issue No.	48	
LM End	3.50	Issue Type +	Ma	Location *		
Category	Supplemental			GPS Latitude/Longitude		
				Start	End	
Item	DWR UCIP LMA Responsibility			39.760847 °	39.760847 °	
				-121.910265 °	-121.910265 °	
DWR ID						
Comment Code						
Inspector Comment						
FS_ID:30803 DS_ID:19241 EP_NO: N/A Repair Type: Non-Urgent Crossing Status: Found UCIP Comments: Needs cleaning and clearing of debris. FIELD_STRUCT_DESC: 24-inch corrugated metal gravity drainage pipe through the levee, 6.5 feet below the crown. Flap gate on the waterside (WS) end. Concrete U-shaped headwall on each end. Grouted riprap apron on the landside (LS) end. Grouted riprap spillway on the WS end. [Additional Reference(s): DWR Levee Log, 1992. USACE Sacramento O&M Manual 504, May 1965, (HLM 3.64)]. FS Date: 2/24/2014

WS view: U type concrete headwall, pipe, and flapgate on levee slope. Vegetation debris and soil blocking outlet.

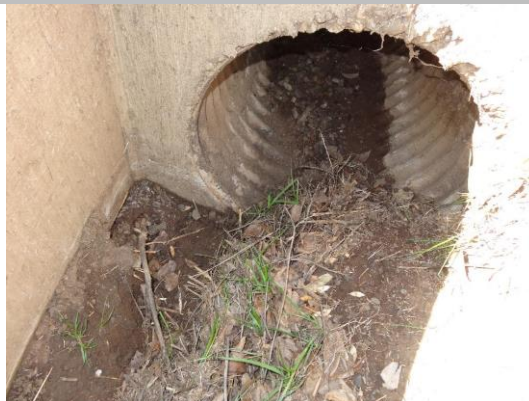
Photo 2 of 3 : UCIP_SP_2018_31028_56912.jpg

LM Start	4.61	Rating **	M	Issue No.	49 (cont)	
LM End	4.61	Issue Type +	Ma	Location *		
Category	Supplemental			GPS Latitude/Longitude		
				Start		End
Item	DWR UCIP LMA Responsibility			39.748731 °		39.748731 °
				-121.917577 °		-121.917577 °
DWR ID						
Comment Code						
Inspector Comment						
FS_ID:31028 DS_ID:19245 EP_NO: N/A Repair Type: Non-Urgent Crossing Status: Found UCIP Comments: Needs cleaning and clearing of debris. FIELD_STRUCT_DESC: 24-inch corrugated metal gravity drainage pipe through the levee, 10 feet below the crown. Flap gate on the waterside (WS) end. Concrete U-shaped headwall on each end. Grouted riprap apron on the landside (LS) end. Grouted riprap spillway on the WS end. [Additional Reference(s): DWR Levee Log, 1992. USACE Sacramento O&M Manual 504, May 1965, (HLM 4.77)]. FS Date: 2/25/2014

LS view: U type concrete headwall and CMP on levee slope.

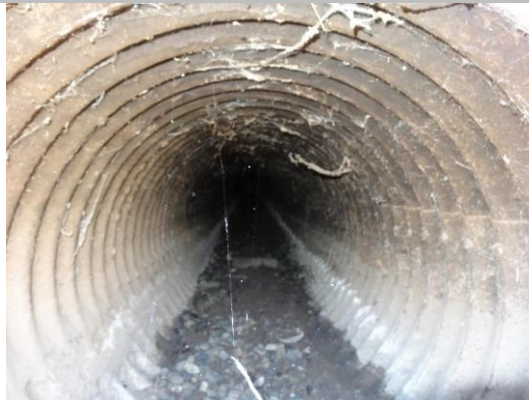
Photo 3 of 3 : UCIP_SP_2018_31028_56911.jpg

LS view: inside view of CMP on levee slope. Needs cleaning and clearing.

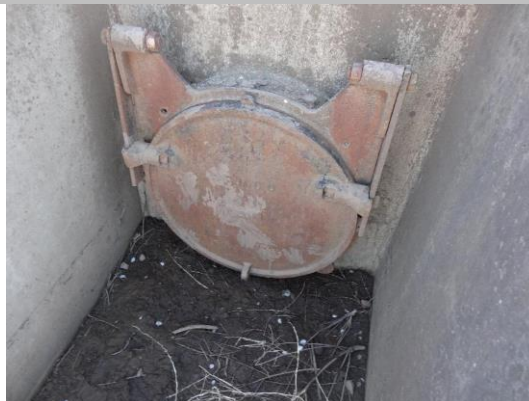
Photo 1 of 3 : UCIP_SP_2018_31031_56917.jpg

LM Start	5.64	Rating **	M	Issue No.	50
LM End	5.64	Issue Type +	Ma	Location *	
Category	Supplemental			GPS Latitude/Longitude	
				Start	End
Item	DWR UCIP LMA Responsibility			39.738898 °	39.738898 °
				-121.930242 °	-121.930242 °
DWR ID					
Comment Code					
Inspector Comment					
FS_ID:31031 DS_ID:19247 EP_NO: N/A Repair Type: Non-Urgent Crossing Status: Found UCIP Comments: Needs cleaning and clearing of debris. FIELD_STRUCT_DESC: 24-inch corrugated metal gravity drainage pipe through the levee, 11.5 feet below the crown. Flap gate on the waterside (WS) end. Concrete U-shaped headwall on each end. Grouted riprap apron on the landside (LS) end. Grouted riprap spillway on the WS end. [Additional Reference(s): DWR Levee Log, 1992. USACE Sacramento O&M Manual 504, May 1965, (HLM 5.83)]. FS Date: 2/25/2014

WS view: U type concrete headwall, pipe, and flapgate on levee slope. Soil/mud on outlet box.

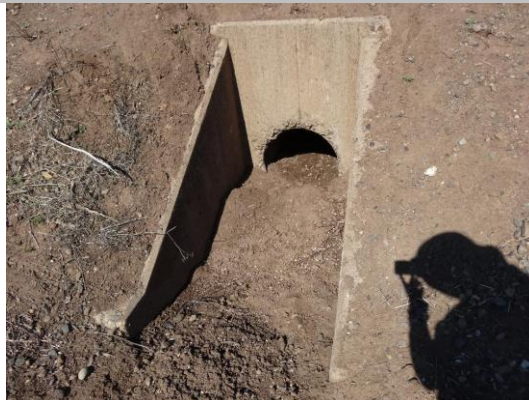
Photo 2 of 3 : UCIP_SP_2018_31031_56916.jpg

LS view: U type concrete headwall and CMP on levee slope. Soil/mud on inlet box.

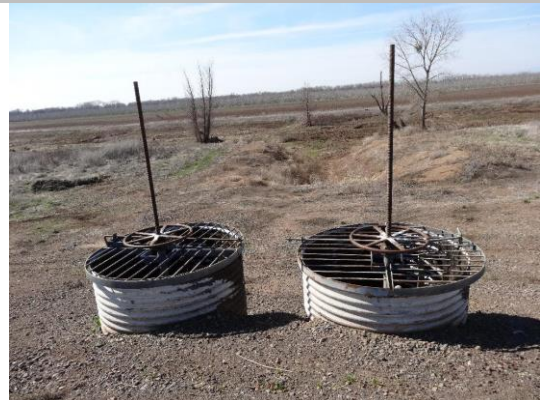
Photo 1 of 3 : UCIP_SP_2018_41376_56920.jpg

Comment Code						
Inspector Comment						
FS_ID:41376						
DS_ID:19248						
EP_NO: N/A						
Repair Type: Non-Urgent						
Crossing Status: Found						
UCIP Comments: Needs cleaning and clearing of debris.						
FIELD_STRUCT_DESC: [Channel Slough Drainage Structure] 1 of 2: 42-inch corrugated metal gravity drainage pipe through the levee, 16 feet below the crown. Flap gate on the waterside (WS) end. Slide gate in a corrugated metal pipe (CMP) riser on the WS slope. Concrete U-shaped headwall on each end. Grouted riprap apron and rock revetment on the landside (LS) end. [Additional Reference(s): DWR Levee Log, 1992. USACE Sacramento O&M Manual 504, May 1965, (HLM 6.30)].						
FS Date: 2/25/2014

WS view: slide gates in CMP risers on levee slope.

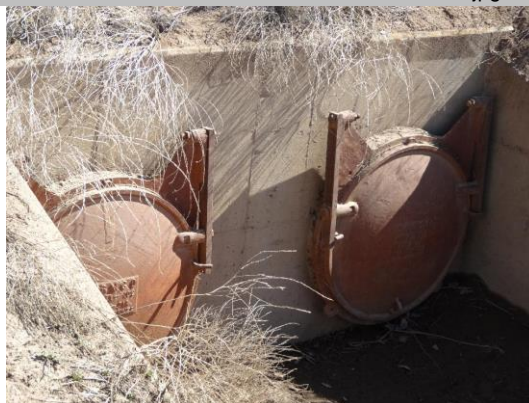
Photo 2 of 3 : UCIP_SP_2018_41376_56919.jpg

FS_ID:41376
DS_ID:19248
EP_NO: N/A
Repair Type: Non-Urgent
Crossing Status: Found
UCIP Comments: Needs cleaning and clearing of debris.
FIELD_STRUCT_DESC: [Channel Slough Drainage Structure] 1 of 2:
42-inch corrugated metal gravity drainage pipe through the levee, 16 feet below the crown. Flap gate on the waterside (WS) end. Slide gate in a corrugated metal pipe (CMP) riser on the WS slope. Concrete U-shaped headwall on each end. Grouted riprap apron and rock revetment on the landside (LS) end. [Additional Reference(s): DWR Levee Log, 1992. USACE Sacramento O&M Manual 504, May 1965, (HLM 6.30)].
FS Date: 2/25/2014

WS view: U type concrete headwall, pipes, and flapgates on levee slope. Vegetation debris on outlet box.

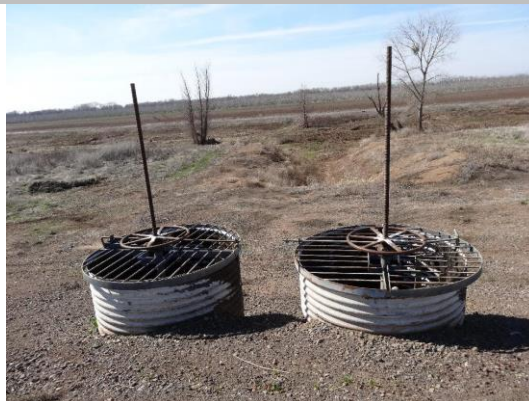
Photo 1 of 3 : UCIP_SP_2018_41377_56923.jpg

Comment Code					
Inspector Comment					
FS_ID:41377 DS_ID:19259 EP_NO: N/A Repair Type: Non-Urgent Crossing Status: Found UCIP Comments: Needs cleaning and clearing of debris. FIELD_STRUCT_DESC: [Channel Slough Drainage Structure] 2 of 2: 42-inch corrugated metal gravity drainage pipe through the levee, 16 feet below the crown. Flap gate on the waterside (WS) end. Slide gate in a corrugated metal pipe (CMP) riser on the WS slope. Concrete U-shaped headwall on each end. Grouted riprap apron and rock revetment on the landside (LS) end. [Additional Reference(s): DWR Levee Log, 1992. USACE Sacramento O&M Manual 504, May 1965, (HLM 6.30)]. FS Date: 2/25/2014

WS view: slide gates in CMP risers on levee slope.

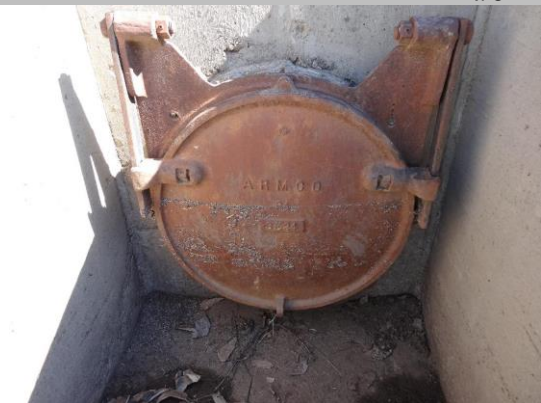
Photo 1 of 3 : UCIP_SP_2018_31034_56926.jpg

LM Start	6.15	Rating **	M	Issue No.	53
LM End	6.15	Issue Type +	Ma	Location *	
Category	Supplemental			GPS Latitude/Longitude	
				Start	End
Item	DWR UCIP LMA Responsibility			39.732515 °	39.732515 °
				-121.930373 °	-121.930373 °
DWR ID					
Comment Code					
Inspector Comment					
FS_ID:31034					
DS_ID:19249					
EP_NO: N/A					
Repair Type: Non-Urgent					
Crossing Status: Found					
UCIP Comments: Needs cleaning and clearing of debris.					
FIELD_STRUCT_DESC: 24-inch corrugated metal gravity drainage pipe through the levee, 12 feet below the crown. Flap gate on the waterside (WS) end. Concrete U-shaped headwall on each end. Grouted riprap apron on the landside (LS) end. Grouted riprap spillway on the WS end. [Additional Reference(s): DWR Levee Log, 1992. USACE Sacramento O&M Manual 504, May 1965, (HLM 6.35)].					
FS Date: 2/25/2014

WS view: U type concrete headwall, pipe, and flapgate on levee slope.

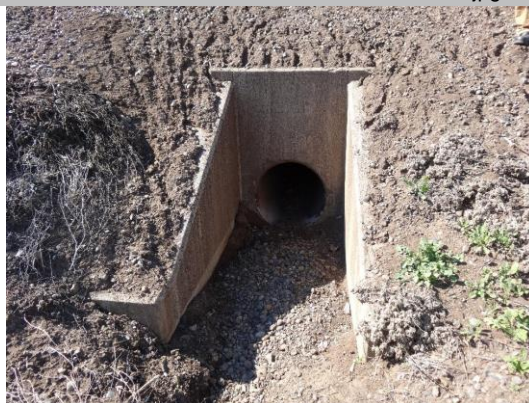
Photo 2 of 3 : UCIP_SP_2018_31034_56925.jpg

LS view: U type concrete headwall and CMP on levee slope.

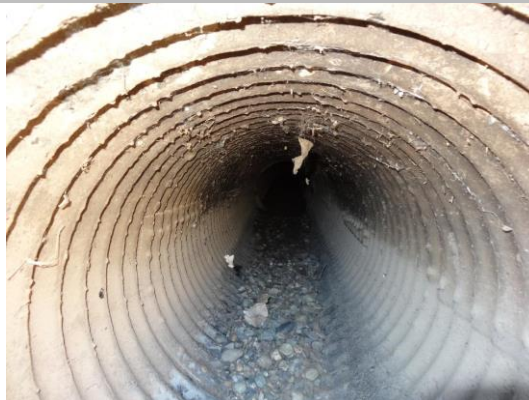
Photo 3 of 3 : UCIP_SP_2018_31034_56924.jpg

LS view: inside view of CMP on levee slope. Needs cleaning and clearing.

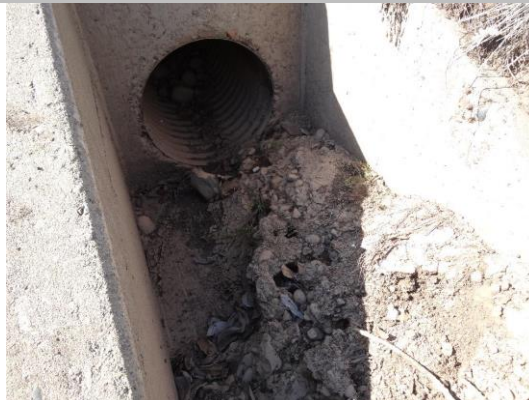
Photo 2 of 3 : UCIP_SP_2018_31085_56987.jpg

LS view: U type concrete headwall and CMP on levee slope. Soil/mud on inlet box.

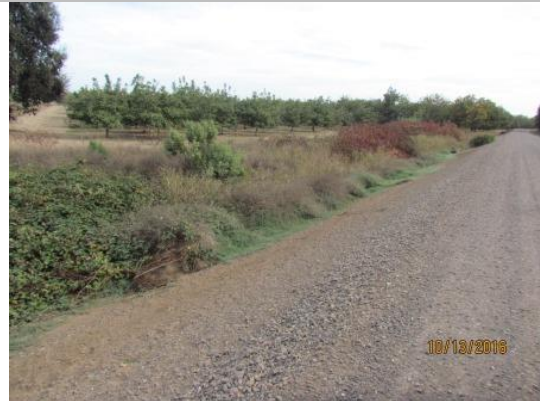
Photo 1 of 1 : SP_2018_NA0003_65_40_20180305_00017.jpg

LM Start	7.17	Rating **	M	Issue No.	40
LM End	7.22	Issue Type +	Ma	Location *	LS
Category	Earthen Levee			GPS Latitude/Longitude	
				Start	End
Item	Vegetation			39.719593 °	39.718933 °
				-121.938137 °	-121.937635 °
DWR ID	DWR_NA0003_02_f_2016_40				
Comment Code					
V2 : Remove the wild growth other than native grasses from the levee slopes.					
Inspector Comment

View of the dense vegetation along the landside toe blocking visibility and access.

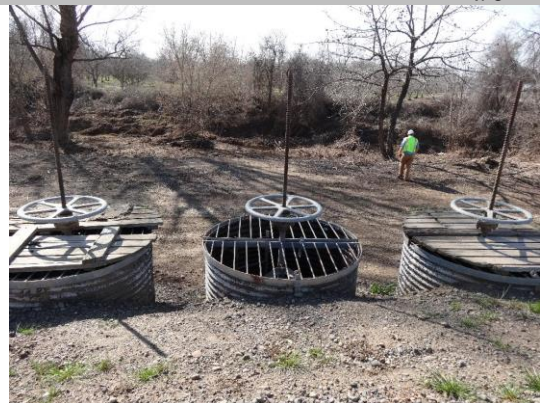
Photo 1 of 3 : UCIP_SP_2018_32086_58589.jpg

Comment Code					
Inspector Comment					
FS_ID:32086 DS_ID:19260 EP_NO: N/A Repair Type: Non-Urgent Crossing Status: Found UCIP Comments: Slide gates in CMP risers on waterside shoulder.Needs cleaning and clearing of debris. FIELD_STRUCT_DESC: 2 of 3: 48-inch corrugated metal gravity drainage pipe through the levee, 18 feet below the crown. Flap gate on the waterside (WS) end. Slide gate in a corrugated metal pipe (CMP) riser on the WS shoulder. Concrete U-shaped headwall on each end. Grouted riprap apron on the landside (LS) end. Grouted riprap spillway on the WS end. [Additional Reference(s): DWR Levee Log, 1992. USACE Sacramento O&M Manual 504, May 1965, (HLM 7.46)]. FS Date: 2/25/2014

WS view: slide gates in CMP risers on waterside shoulder.

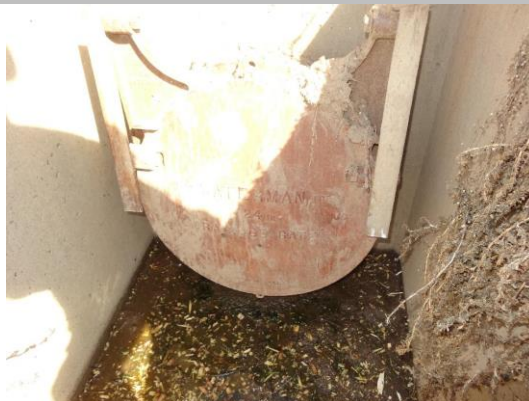
Photo 1 of 2 : UCIP_SP_2018_31129_57036.jpg

LM Start	7.77	Rating **	M	Issue No.	59
LM End	7.77	Issue Type +	Ma	Location *	
Category	Supplemental			GPS Latitude/Longitude	
				Start	End
Item	DWR UCIP LMA Responsibility			39.711436 °	39.711436 °
				-121.937135 °	-121.937135 °
DWR ID					
Comment Code					
Inspector Comment					
FS_ID:31129 DS_ID:19254 EP_NO: N/A Repair Type: Non-Urgent Crossing Status: Found UCIP Comments: Debris in inlet pipe, needs cleaning and clearing. FIELD_STRUCT_DESC: 24-inch corrugated metal gravity drainage pipe through the levee, 18 feet below the crown. Flap gate on the waterside (WS) end. Concrete U-shaped headwall on each end. Grouted riprap apron on the landside (LS) end. Grouted riprap spillway on the WS end. [Additional Reference(s): DWR Levee Log, 1992. USACE Sacramento O&M Manual 504, May 1965, (HLM 8.09)]. FS Date: 2/25/2014

WS view: U type concrete headwall, pipe, and flapgate on levee slope.
Soil/mud on outlet box.

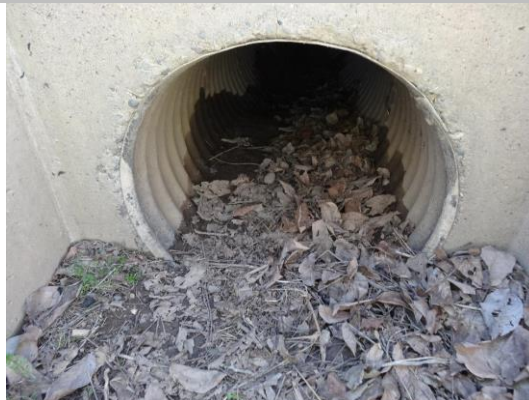
Photo 2 of 2 : UCIP_SP_2018_31129_57035.jpg

LS view: U type concrete headwall and CMP on levee slope. Soil/mud and vegetation on inlet box.

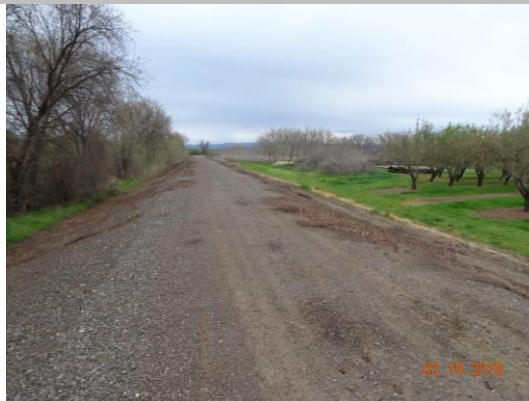
Photo 1 of 1 : SP_2018_NA0003_66_3_20180402_00001.jpg

LM Start	0.10	Rating **	A	Issue No.	3
LM End	0.10	Issue Type +	Ma	Location *	LS
Category	Earthen Levee			GPS Latitude/Longitude	
				Start	End
Item	Vegetation			39.734240 °	39.734240 °
				-121.929565 °	-121.929565 °
DWR ID	DWR_NA0003_02A_s_2018_3				
Comment Code					
V1 : Control annual grass and weeds on the levee slopes and easements.					
Inspector Comment					
There is no vegetation on both slopes.

View of no vegetation on both slopes.

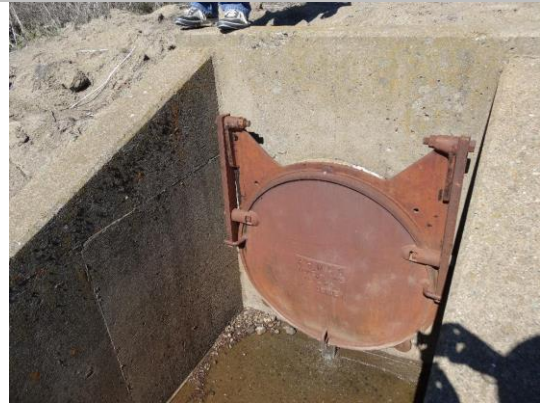
Photo 1 of 3 : UCIP_SP_2018_51844_58602.jpg

WS view: U type concrete headwall, pipe, and flapgate on levee slope.

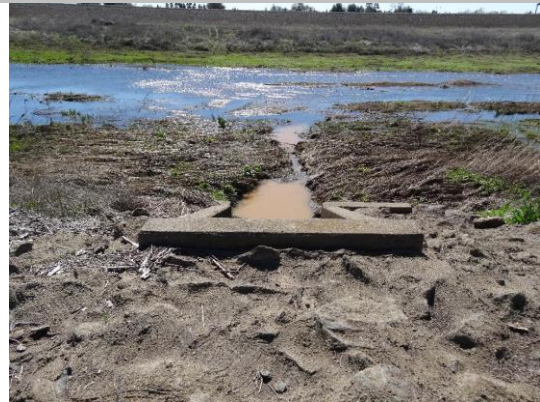
Photo 2 of 3 : UCIP_SP_2018_51844_58601.jpg

WS view: U type concrete headwall of CMP culvert on levee slope.
Grouted riprap levee slope and spillway.

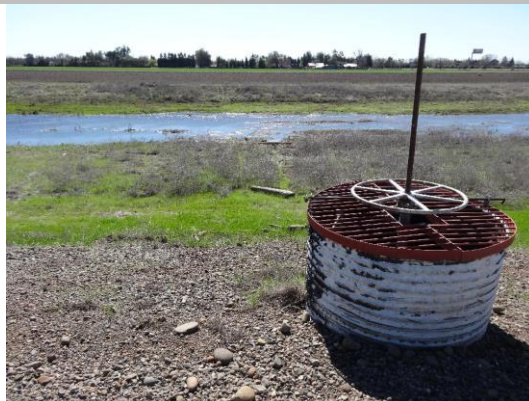
Photo 3 of 3 : UCIP_SP_2018_51844_58600.jpg

WS view: slide gate in CMP riser on waterside shoulder.

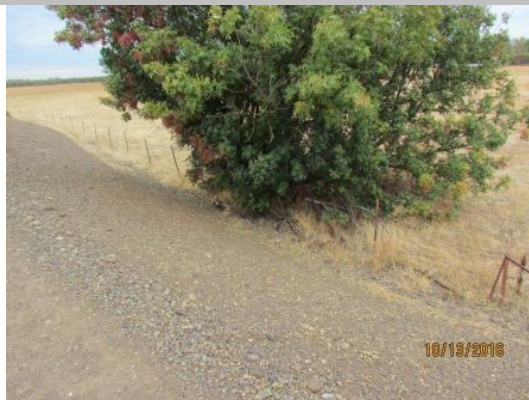
Photo 1 of 1 : SP_2018_NA0003_67_15_20180305_00004.jpg

LM Start	0.35	Rating **	M	Issue No.	15
LM End	0.35	Issue Type +	Ma	Location *	LS
Category	Earthen Levee			GPS Latitude/Longitude	
				Start	End
Item	Trim / Thin Trees			39.785704 °	39.785704 °
				-121.877004 °	-121.877004 °
DWR ID	DWR_NA0003_03_f_2016_15				
Comment Code					
T1 : Trim trees to at least five feet above ground level.					
Inspector Comment

View of the overgrown tree along the landside slope.

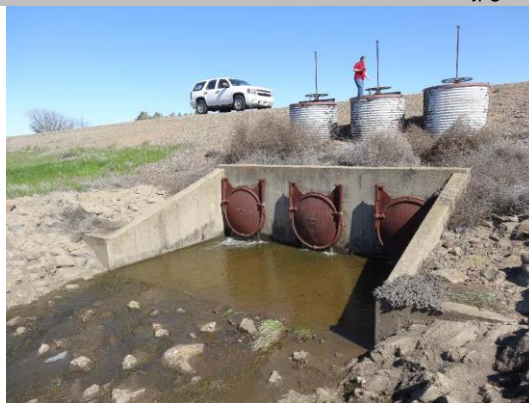
Photo 1 of 2 : UCIP_SP_2018_32104_58606.jpg

WS view: U type concrete headwall and three CMPs with slide gates on levee slope. Grouted riprap spillway.

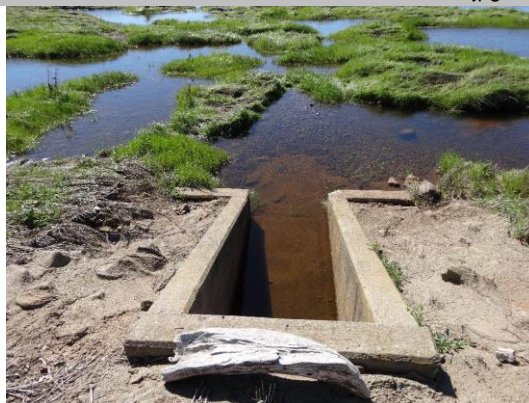
Photo 1 of 3 : UCIP_SP_2018_32107_58613.jpg

WS view: U type concrete headwall and grouted riprap on levee slope.

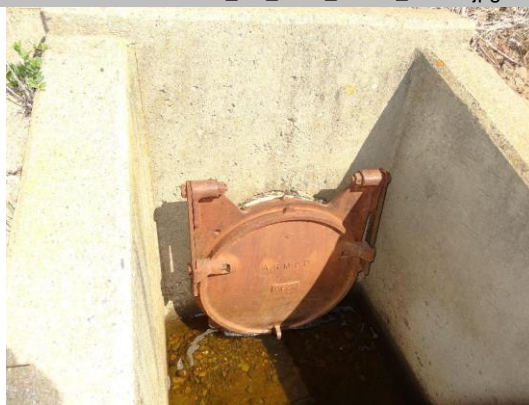
Photo 2 of 3 : UCIP_SP_2018_32107_58612.jpg

WS view: U type concrete headwall, flapgate, and CMP on levee slope.

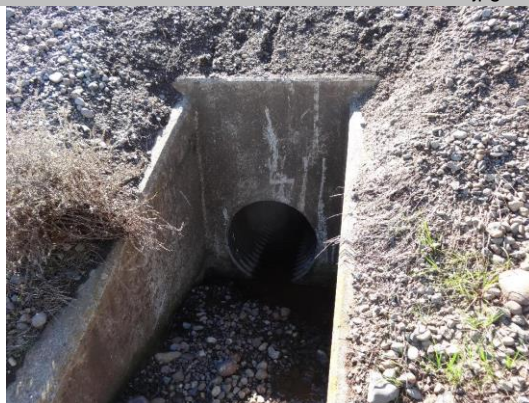
Photo 3 of 3 : UCIP_SP_2018_32107_58611.jpg

LS view: U type concrete headwall and CMP on levee slope.

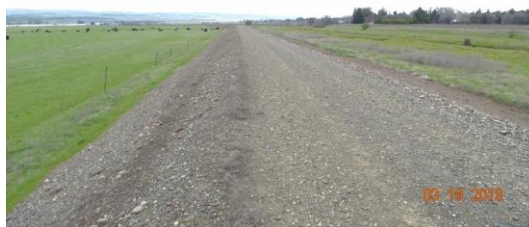
Photo 1 of 1 : SP_2018_NA0003_67_22_20180402_00038.jpg

LM Start	1.34	Rating **	A	Issue No.	22
LM End	1.34	Issue Type +	Ma	Location *	LS
Category	Earthen Levee			GPS Latitude/Longitude	
				Start	End
Item	Vegetation			39.779405 °	39.779405 °
				-121.860965 °	-121.860965 °
DWR ID	DWR_NA0003_03_s_2018_22				
Comment Code					
V1 : Control annual grass and weeds on the levee slopes and easements.					
Inspector Comment					
There is no vegetation on both slopes.

View of the levee with no vegetation on both slopes.

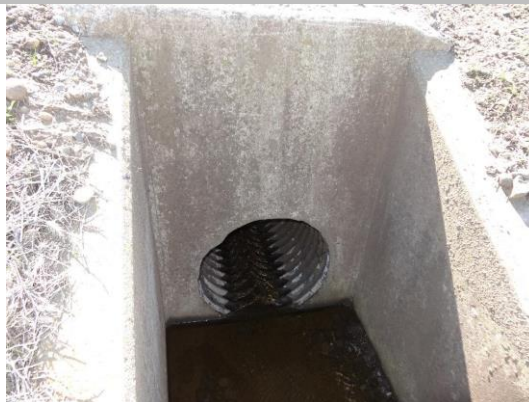
Photo 2 of 2 : UCIP_SP_2018_31899_58186.jpg

LS view: U type concrete headwall and CMP on levee slope. Looks clean and clear.

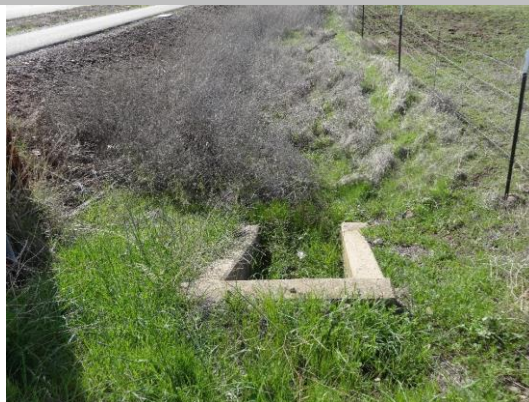
Photo 2 of 3 : UCIP_SP_2018_32124_58624.jpg

LS view: U type concrete headwall of CMP culvert on levee slope.
Vegetation on inlet box.

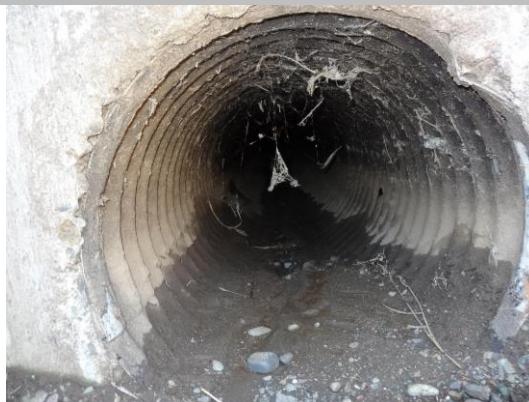
Photo 3 of 3 : UCIP_SP_2018_31901_58195.jpg

LS view: inside view of CMP on levee slope. Needs cleaning and clearing.

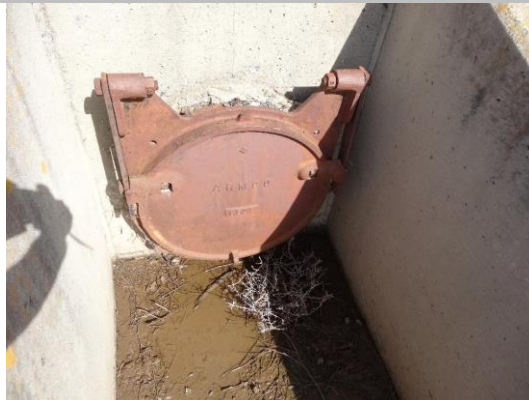
Photo 2 of 3 : UCIP_SP_2018_31902_58200.jpg

WS view: U type concrete headwall and CMP on levee slope.

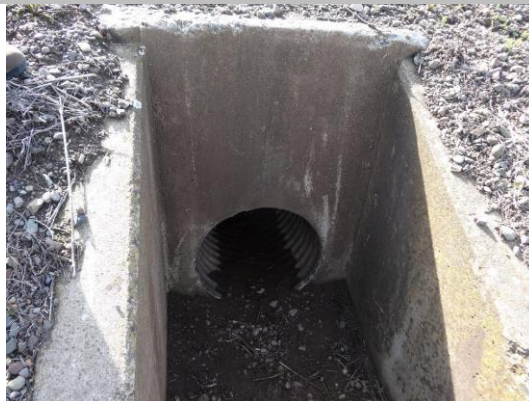
Photo 2 of 3 : UCIP_SP_2018_31864_58068.jpg

FS_ID:31864
DS_ID:19271
EP_NO: N/A
Repair Type: Non-Urgent
Crossing Status: Found
UCIP Comments: Needs cleaning and clearing the culvert.
FIELD_STRUCT_DESC: 24-inch corrugated metal gravity drainage pipe through the levee, 10.5 feet below the crown. Flap gate on the waterside (WS) end. Concrete U-shaped headwall on each end. Grouted riprap apron on the landside (LS) end. Grouted riprap spillway on the WS end. [Additional Reference(s): DWR Levee Log, 1992. USACE Sacramento O&M Manual 504, May 1965, (HLM 3.43)].
FS Date: 3/7/2014

LS view: U type concrete headwall and CMP on levee slope. Soil/mud on inlet box.

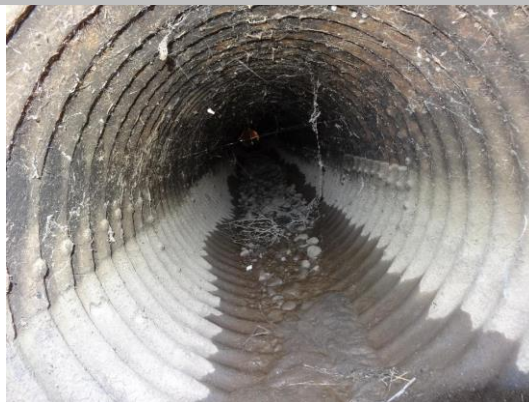
Photo 3 of 3 : UCIP_SP_2018_31864_58067.jpg

LS view: inside view of CMP on levee slope. Needs cleaning and clearing.

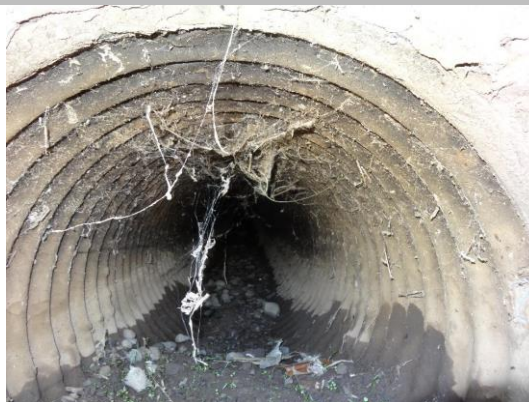
Photo 3 of 3 : UCIP_SP_2018_31856_58051.jpg

LS view: inside view of CMP on levee slope. Needs cleaning and clearing.

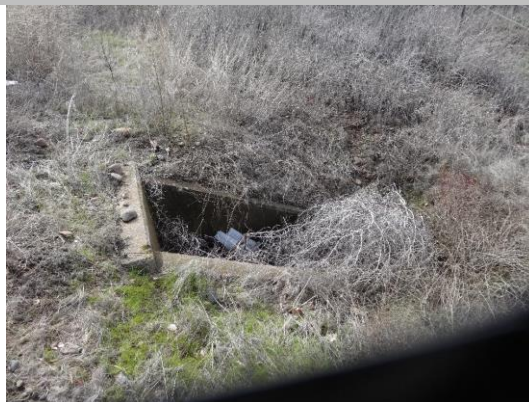
Photo 2 of 2 : UCIP_SP_2018_32125_58628.jpg

LS view: U type concrete headwall and pipe on levee slope. Soil/mud on inlet box. Vegetation debris blocking inlet box.

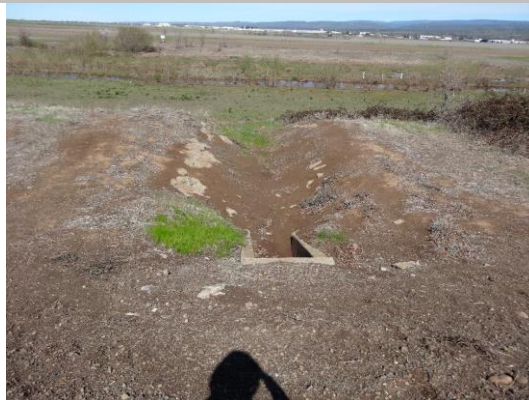
Photo 1 of 3 : UCIP_SP_2018_32026_58520.jpg

WS view: concrete headwall and grouted riprap spillway on levee slope.

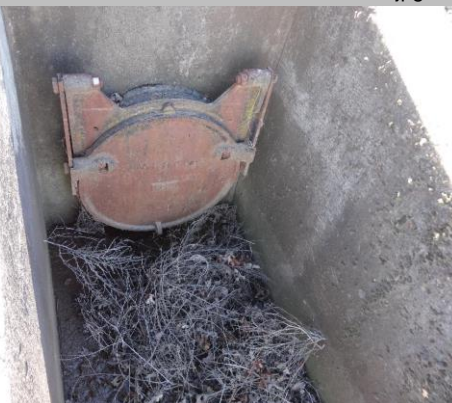
Photo 2 of 3 : UCIP_SP_2018_32026_58519.jpg

Comment Code						
Inspector Comment						
FS_ID:32026						
DS_ID:19279						
EP_NO: N/A						
Repair Type: Non-Urgent						
Crossing Status: Found						
UCIP Comments: Needs cleaning and clearing the culvert.						
FIELD_STRUCT_DESC: 24-inch corrugated metal gravity drainage pipe						
through the levee, 10 feet below the crown. Flap gate on the waterside						
(WS) end. Concrete U-shaped headwall on each end. Grouted riprap						
apron on the landside (LS) end. Grouted riprap spillway on the WS end.						
[Additional Reference(s): DWR Levee Log, 1992. USACE Sacramento						
O&M Manual 504, May 1965, (HLM 0.28)].						
FS Date: 3/7/2014

WS view: U type concrete headwall and CMP on levee slope. Mud and vegetation debris on outlet box.

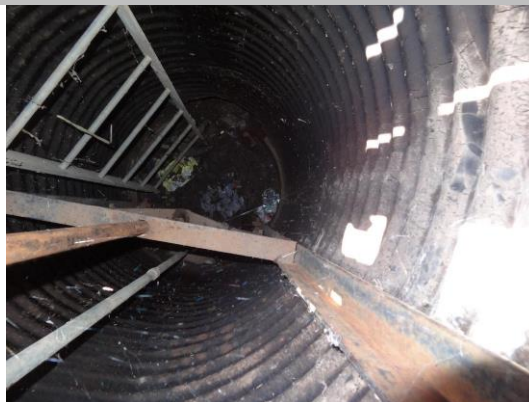
Photo 2 of 3 : UCIP_SP_2018_32025_58511.jpg

WS view: inside view of slide gate in CMP riser on waterside shoulder.
Debris trapped in the riser.

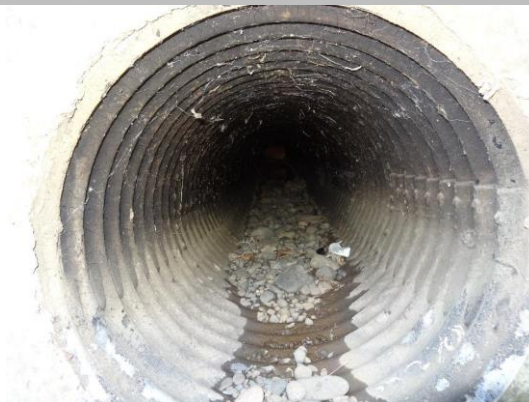
Photo 3 of 3 : UCIP_SP_2018_32023_58503.jpg

LS view: inside view of the CM pipe. Needs cleaning and clearing the pipe.

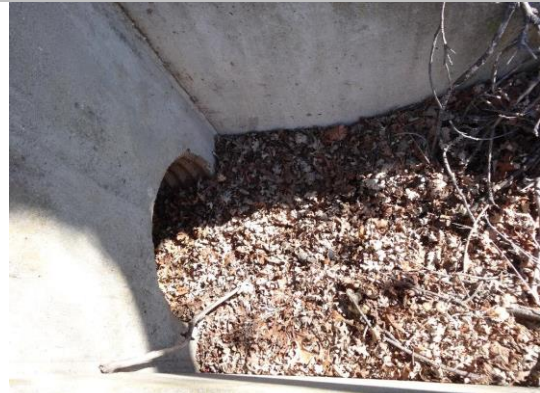
Photo 2 of 2 : UCIP_SP_2018_32143_58640.jpg

LM Start	0.92	Rating **	M	Issue No.	28 (cont)	
LM End	0.92	Issue Type +	Ma	Location *		
Category	Supplemental			GPS Latitude/Longitude		
				Start	End	
Item	DWR UCIP LMA Responsibility			39.775704 °	39.775704 °	
				-121.850901 °	-121.850901 °	
DWR ID						
Comment Code						
Inspector Comment						
FS_ID:32143						
DS_ID:19287						
EP_NO: N/A						
Repair Type: Non-Urgent						
Crossing Status: Found						
UCIP Comments: Needs cleaning and clearing the culvert.						
FIELD_STRUCT_DESC: 24-inch corrugated metal gravity drainage pipe through the levee, 9 feet below the crown. Flap gate on the waterside (WS) end. Concrete U-shaped headwall on each end. Grouted riprap apron on the landside (LS) end. Grouted riprap spillway on the WS end. [Additional Reference(s): DWR Levee Log, 1992. USACE Sacramento O&M Manual 504, May 1965, (HLM 0.96)].						
FS Date: 3/7/2014

LS view: U type concrete headwall and CMP on levee slope. Vegetation and mud on inlet box.

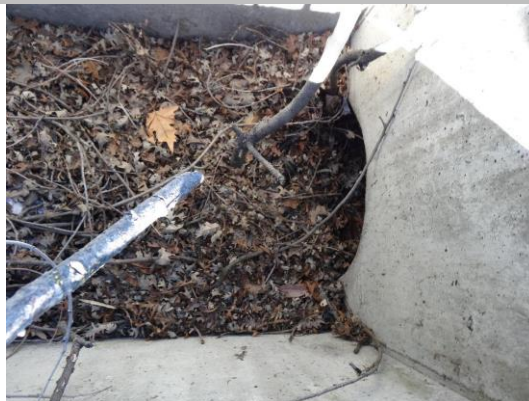
Photo 2 of 3 : UCIP_SP_2018_32144_58643.jpg

FS_ID:32144
DS_ID:19288
EP_NO: N/A
Repair Type: Non-Urgent
Crossing Status: Found
UCIP Comments: Slide gate in CMP riser on waterside. No access to CMP riser. Needs cleaning and clearing the culvert.
FIELD_STRUCT_DESC: 24-inch corrugated metal gravity drainage pipe through the levee and under the channel, 9.5 feet below the crown. Slide gate in a pipe riser on the waterside (WS) slope. Concrete U-shaped headwall on the landside (LS) end. [Additional Reference(s): DWR Levee Log, 1992. USACE Sacramento O&M Manual 504, May 1965, (HLM 0.98)].
FS Date: 3/7/2014

LS view: close view of vegetation debris and mud on inlet box.

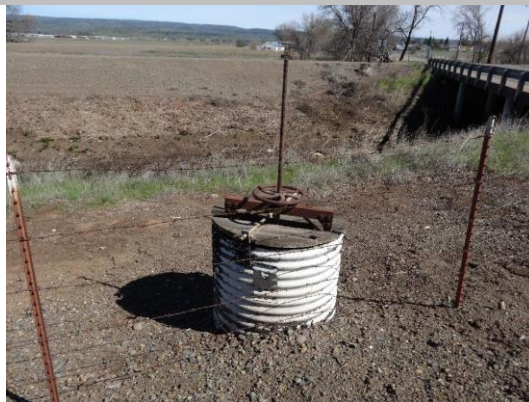
Photo 3 of 3 : UCIP_SP_2018_32144_58642.jpg

WS view: slide gate in CMP riser on waterside. No access to CMP riser.

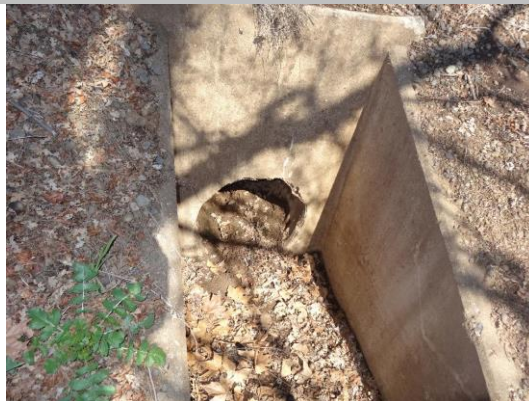
Photo 2 of 3 : UCIP_SP_2018_31963_58383.jpg

LM Start	1.11	Rating **	M	Issue No.	31 (cont)
LM End	1.11	Issue Type +	Ma	Location *	
Category	Supplemental			GPS Latitude/Longitude	
				Start	End
Item	DWR UCIP LMA Responsibility			39.776709 °	39.776709 °
				-121.853932 °	-121.853932 °
DWR ID					
Comment Code					
Inspector Comment					
FS_ID:31963					
DS_ID:19289					
EP_NO: N/A					
Repair Type: Non-Urgent					
Crossing Status: Found					
UCIP Comments: Needs cleaning and clearing the culvert.					
FIELD_STRUCT_DESC: 24-inch corrugated metal gravity drainage pipe through the levee, 11 feet below the crown. Flap gate on the waterside (WS) end. Concrete U-shaped headwall on each end. Grouted riprap apron on the landside (LS) end. Grouted riprap spillway on the WS end. [Additional Reference(s): DWR Levee Log, 1992. USACE Sacramento O&M Manual 504, May 1965, (HLM 1.15)].					
FS Date: 3/7/2014

LS view: U type concrete headwall and CMP on levee slope. Vegetation debris and mud on inlet box.

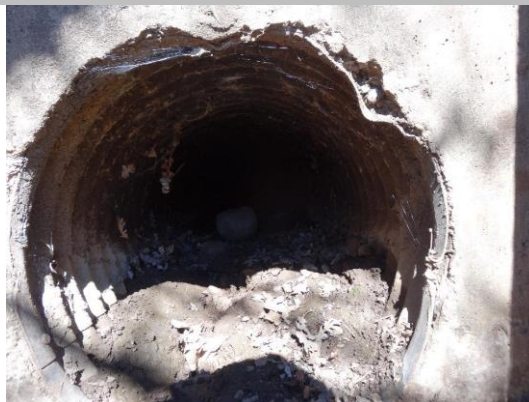
Photo 3 of 3 : UCIP_SP_2018_31963_58385.jpg

LS view: inside view of CMP on levee slope. Needs cleaning and clearing.

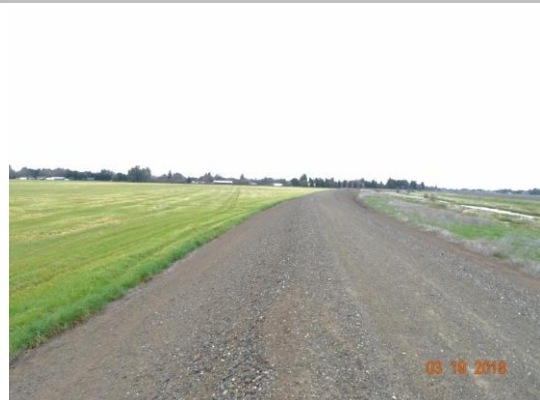
Photo 1 of 1 : SP_2018_NA0003_68_16_20180402_00038.jpg

LM Start	1.54	Rating **	A	Issue No.	16
LM End	1.54	Issue Type +	Ma	Location *	LS
Category	Earthen Levee			GPS Latitude/Longitude	
				Start	End
Item	Vegetation			39.778605 °	39.778605 °
				-121.861485 °	-121.861485 °
DWR ID	DWR_NA0003_04_s_2018_16				
Comment Code					
V1 : Control annual grass and weeds on the levee slopes and easements.					
Inspector Comment					
There is no vegetation on both slopes.

View of the levee with no vegetation on both slopes.

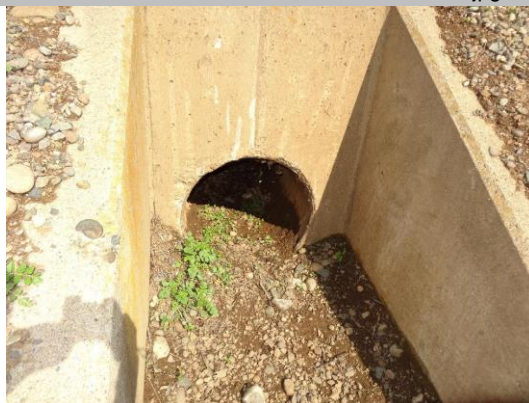
Photo 2 of 3 : UCIP_SP_2018_31965_58394.jpg

LM Start	2.15	Rating **	M	Issue No.	33 (cont)	
LM End	2.15	Issue Type +	Ma	Location *		
Category	Supplemental			GPS Latitude/Longitude		
				Start	End	
Item	DWR UCIP LMA Responsibility			39.782777 °	39.782777 °	
				-121.871179 °	-121.871179 °	
DWR ID						
Comment Code						
Inspector Comment						
FS_ID:31965 DS_ID:19291 EP_NO: N/A Repair Type: Non-Urgent Crossing Status: Found UCIP Comments: Needs cleaning and clearing the culvert. FIELD_STRUCT_DESC: 24-inch corrugated metal gravity drainage pipe through the levee, 11 feet below the crown. Flap gate on the waterside (WS) end. Concrete U-shaped headwall on each end. Grouted riprap apron on the landside (LS) end. Grouted riprap spillway on the WS end. [Additional Reference(s): DWR Levee Log, 1992. USACE Sacramento O&M Manual 504, May 1965, (HLM 2.22)]. FS Date: 3/7/2014

LS view: U type concrete headwall and CMP on levee slope. Vegetation debris and mud in inlet box.

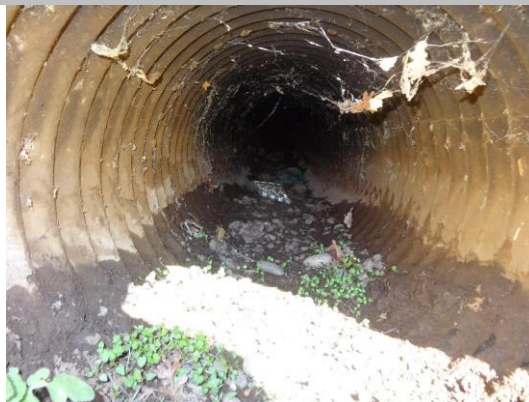
Photo 3 of 3 : UCIP_SP_2018_31965_58393.jpg

LS view: inside view of CMP on levee slope. Needs cleaning and clearing.

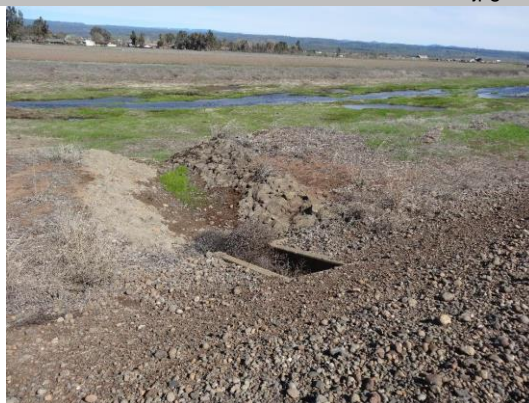
Photo 1 of 3 : UCIP_SP_2018_31966_58401.jpg

LM Start	2.47	Rating **	M	Issue No.	34
LM End	2.47	Issue Type +	Ma	Location *	
Category	Supplemental			GPS Latitude/Longitude	
				Start	End
Item	DWR UCIP LMA Responsibility			39.784244 °	39.784244 °
				-121.876810 °	-121.876810 °
DWR ID					
Comment Code					
Inspector Comment					
FS_ID:31966 DS_ID:19292 EP_NO: N/A Repair Type: Non-Urgent Crossing Status: Found UCIP Comments: Needs cleaning and clearing the culvert. FIELD_STRUCT_DESC: 24-inch corrugated metal gravity drainage pipe through the levee, 11 feet below the crown. Flap gate on the waterside (WS) end. Concrete U-shaped headwall on each end. Grouted riprap apron on the landside (LS) end. Grouted riprap spillway on the WS end. [Additional Reference(s): DWR Levee Log, 1992. USACE Sacramento O&M Manual 504, May 1965, (HLM 2.56)]. FS Date: 3/7/2014

WS view: U type concrete headwall and grouted riprap spillway on levee slope.

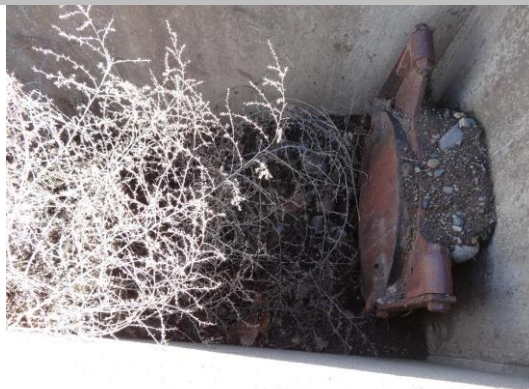
Photo 2 of 3 : UCIP_SP_2018_31966_58400.jpg

WS view: U type concrete headwall and CMP on levee slope. Vegetation debris and mud on outlet box. Needs cleaning and clearing.

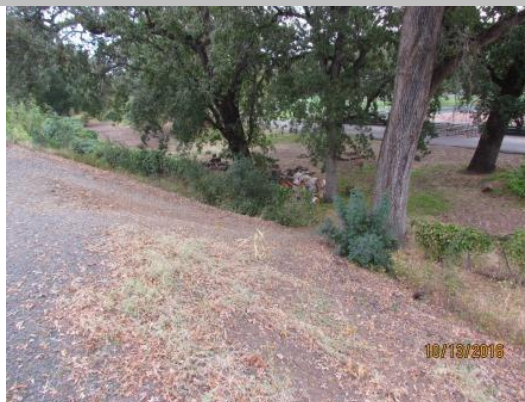
Photo 1 of 1 : SP_2018_NA0003_69_11_20180305_00009.jpg

LM Start	0.42	Rating **	M	Issue No.	11
LM End	0.42	Issue Type +	Ma	Location *	LS
Category	Earthen Levee			GPS Latitude/Longitude	
				Start	End
Item	Slope Stability			39.761077 °	39.761077 °
				-121.796576 °	-121.796576 °
DWR ID	DWR_NA0003_05_f_2016_11				
Comment Code					
S2 : Repair the levee slope damaged by foot traffic and prevent access where possible.					
Inspector Comment

View of the damaged slope by foot traffic.

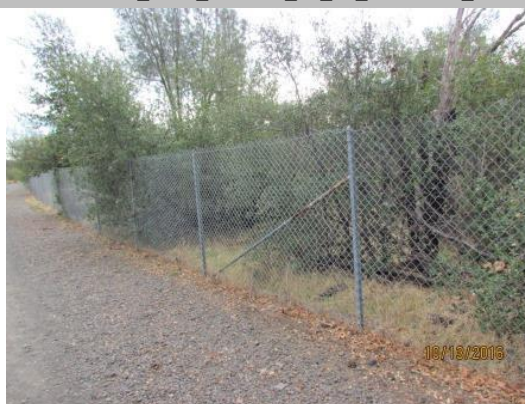
Photo 1 of 1 : SP_2018_NA0003_69_12_20180305_00010.jpg

LM Start	0.50	Rating **	M	Issue No.	12
LM End	0.82	Issue Type +	Ma	Location *	LS
Category	Earthen Levee			GPS Latitude/Longitude	
				Start	End
Item	Trim / Thin Trees			39.761836 °	39.763507 °
				-121.797316 °	-121.802545 °
DWR ID	DWR_NA0003_05_f_2016_12				
Comment Code					
T2 : Thin trees to allow visibility of the ground and room to flood fight.					
Inspector Comment

View of the trees along the landside slope.

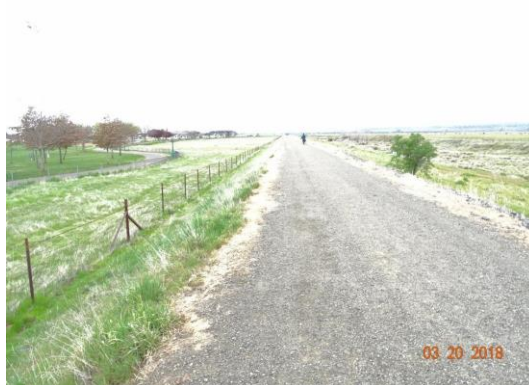
Photo 1 of 2 : SP_2018_NA0003_69_14_20180402_00014.jpg

LM Start	0.85	Rating **	A	Issue No.	14
LM End	1.85	Issue Type +	Ma	Location *	LS
Category	Earthen Levee			GPS Latitude/Longitude	
				Start	End
Item	Vegetation			39.764702 °	39.775426 °
				-121.803562 °	-121.814201 °
DWR ID	DWR_NA0003_05_f_2017_14				
Comment Code					
V2 : Remove the wild growth other than native grasses from the levee slopes.					
Inspector Comment					
There is native grasses from both slopes.

View of the levee with native vegetation on both slopes.

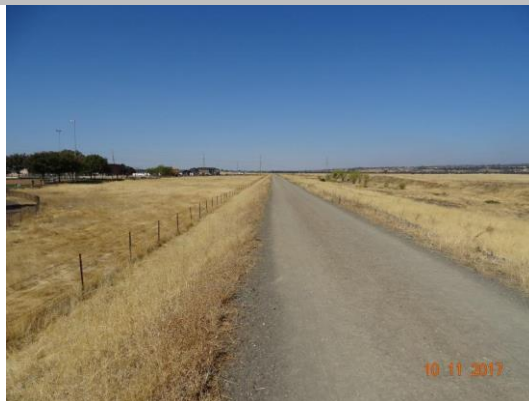
Photo 2 of 2 : SP_2018_NA0003_69_14_20180305_00012.jpg

View of native grasses on both slopes.
